住宅设计-荣誉奖 RESIDENTIAL DESIGN HONOR AWARD

## 曼哈顿岛屋顶露台

# MANHATTAN ROOF TERRACE

Project Statement

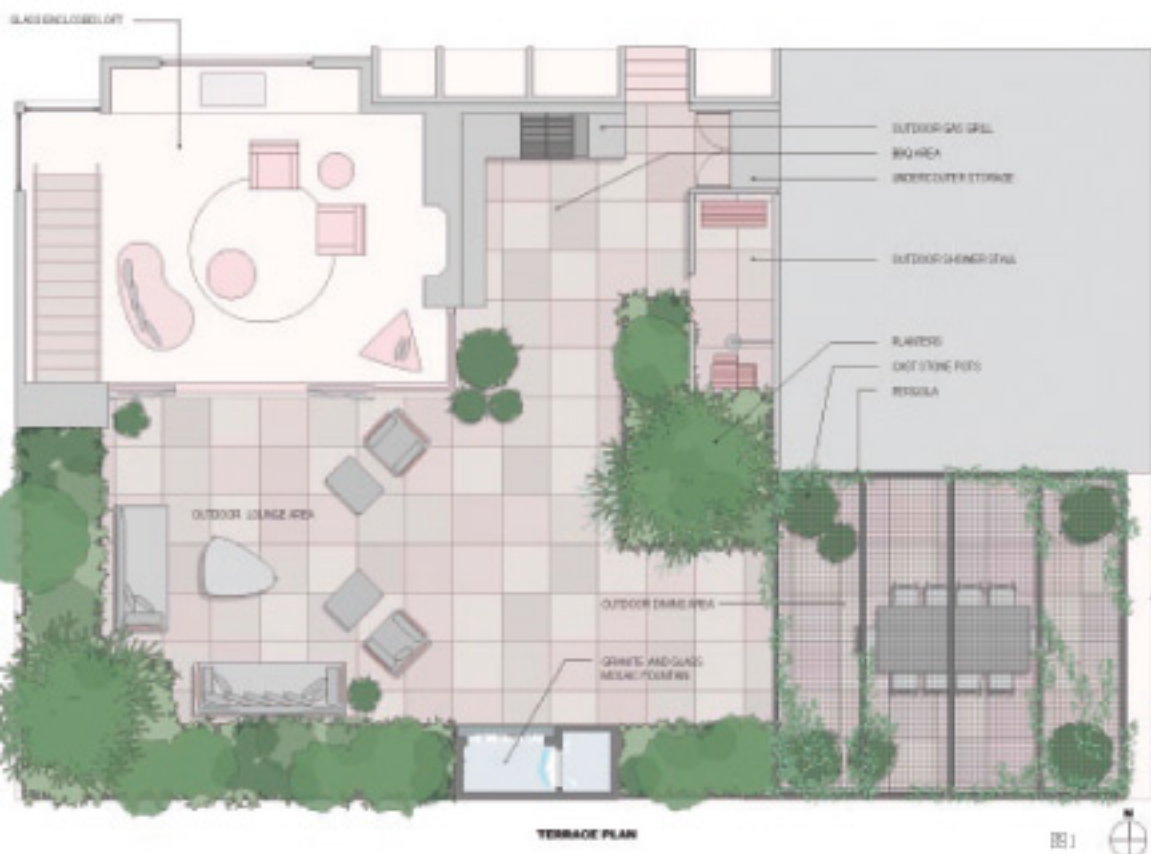
D1 Plan of roof terrace. (Photo: Sawyer/Berson, ASLA Award Recipient)

图1 屋顶露台的平面图 (图片来源: 索亚/百森事务所, ASLA获奖作品)

To create the setting for this 1,428 square foot roof terrace, an existing postmodern roof pavilion was demolished to make way for a modern architectural

framework inspired by the works of American architect Paul Rudolph, and French architects Jean Prouvé and Pierre Chareau. A steel-framed platform was installed, onto which a program of garden elements were placed: a fountain, pergola and planters, as well as an outdoor kitchen and shower.

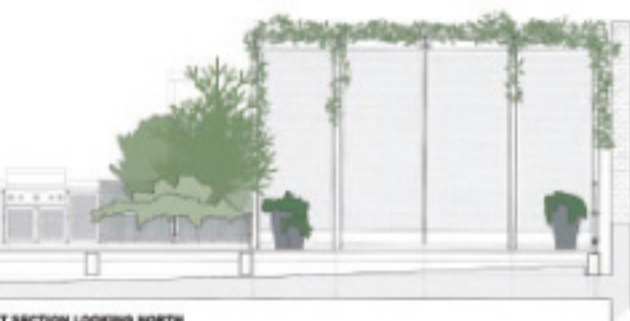
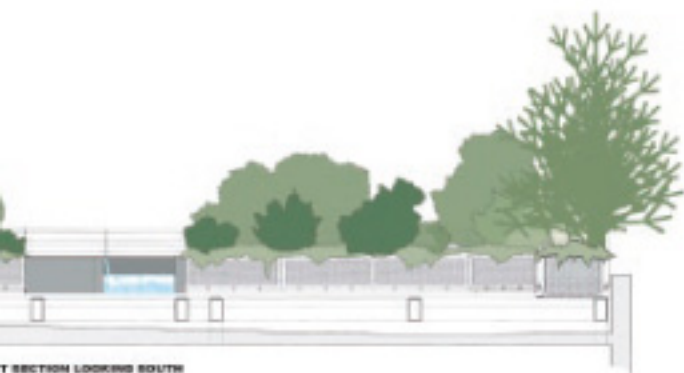
T SECTION LOOKING NORTH

T SECTION LOOKING SOUTH

D2 Two sections of the roof terrace. (Photo: Sawyer/Berson, ASLA Award Recipient)

图2 屋顶露台的两个截面图。(图片来源: 索亚/百森事务所, ASLA获奖作品)

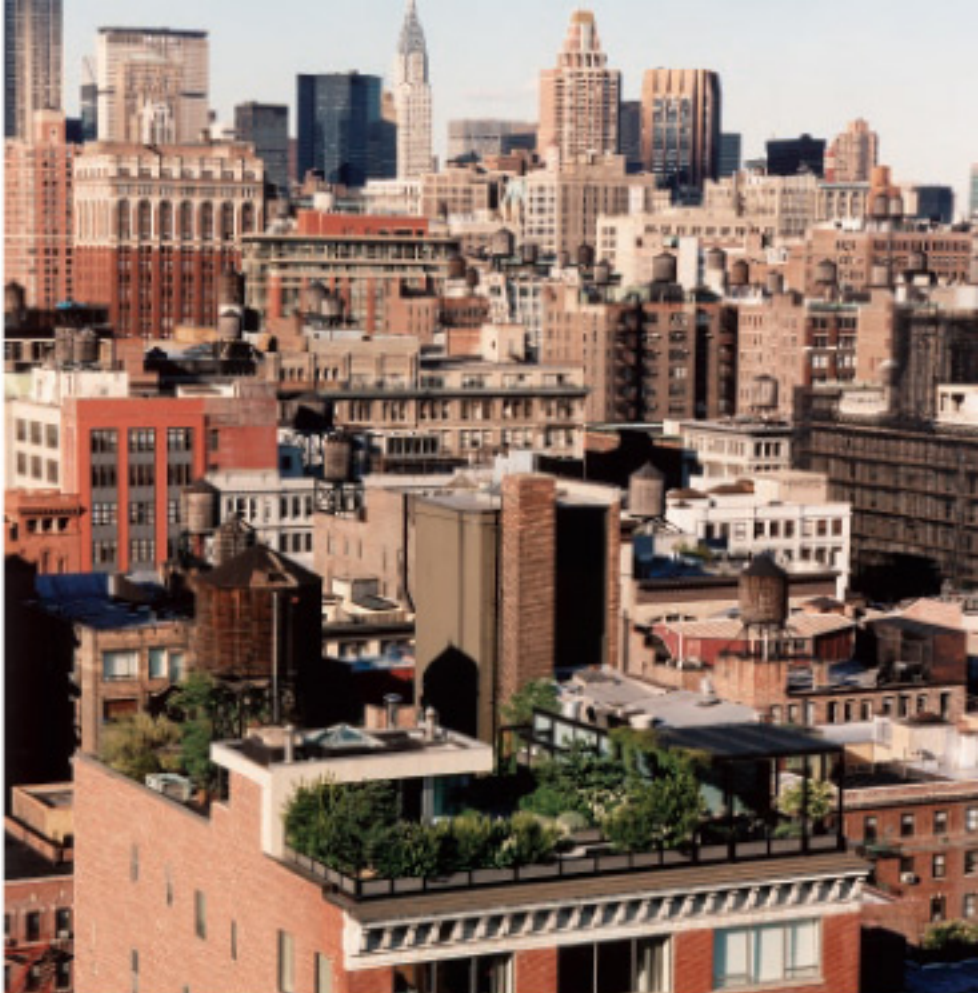
D4 Contextual aerial view of the roof terrace project from the neighboring high-rise apartment building looking north. (Photo: Dana Gallagher, ASLA Award Recipient)

图4 从周围朝北的高层公寓上的俯瞰屋顶露台。(图片来源: 丹娜·伽拉格, ASLA获奖作品)

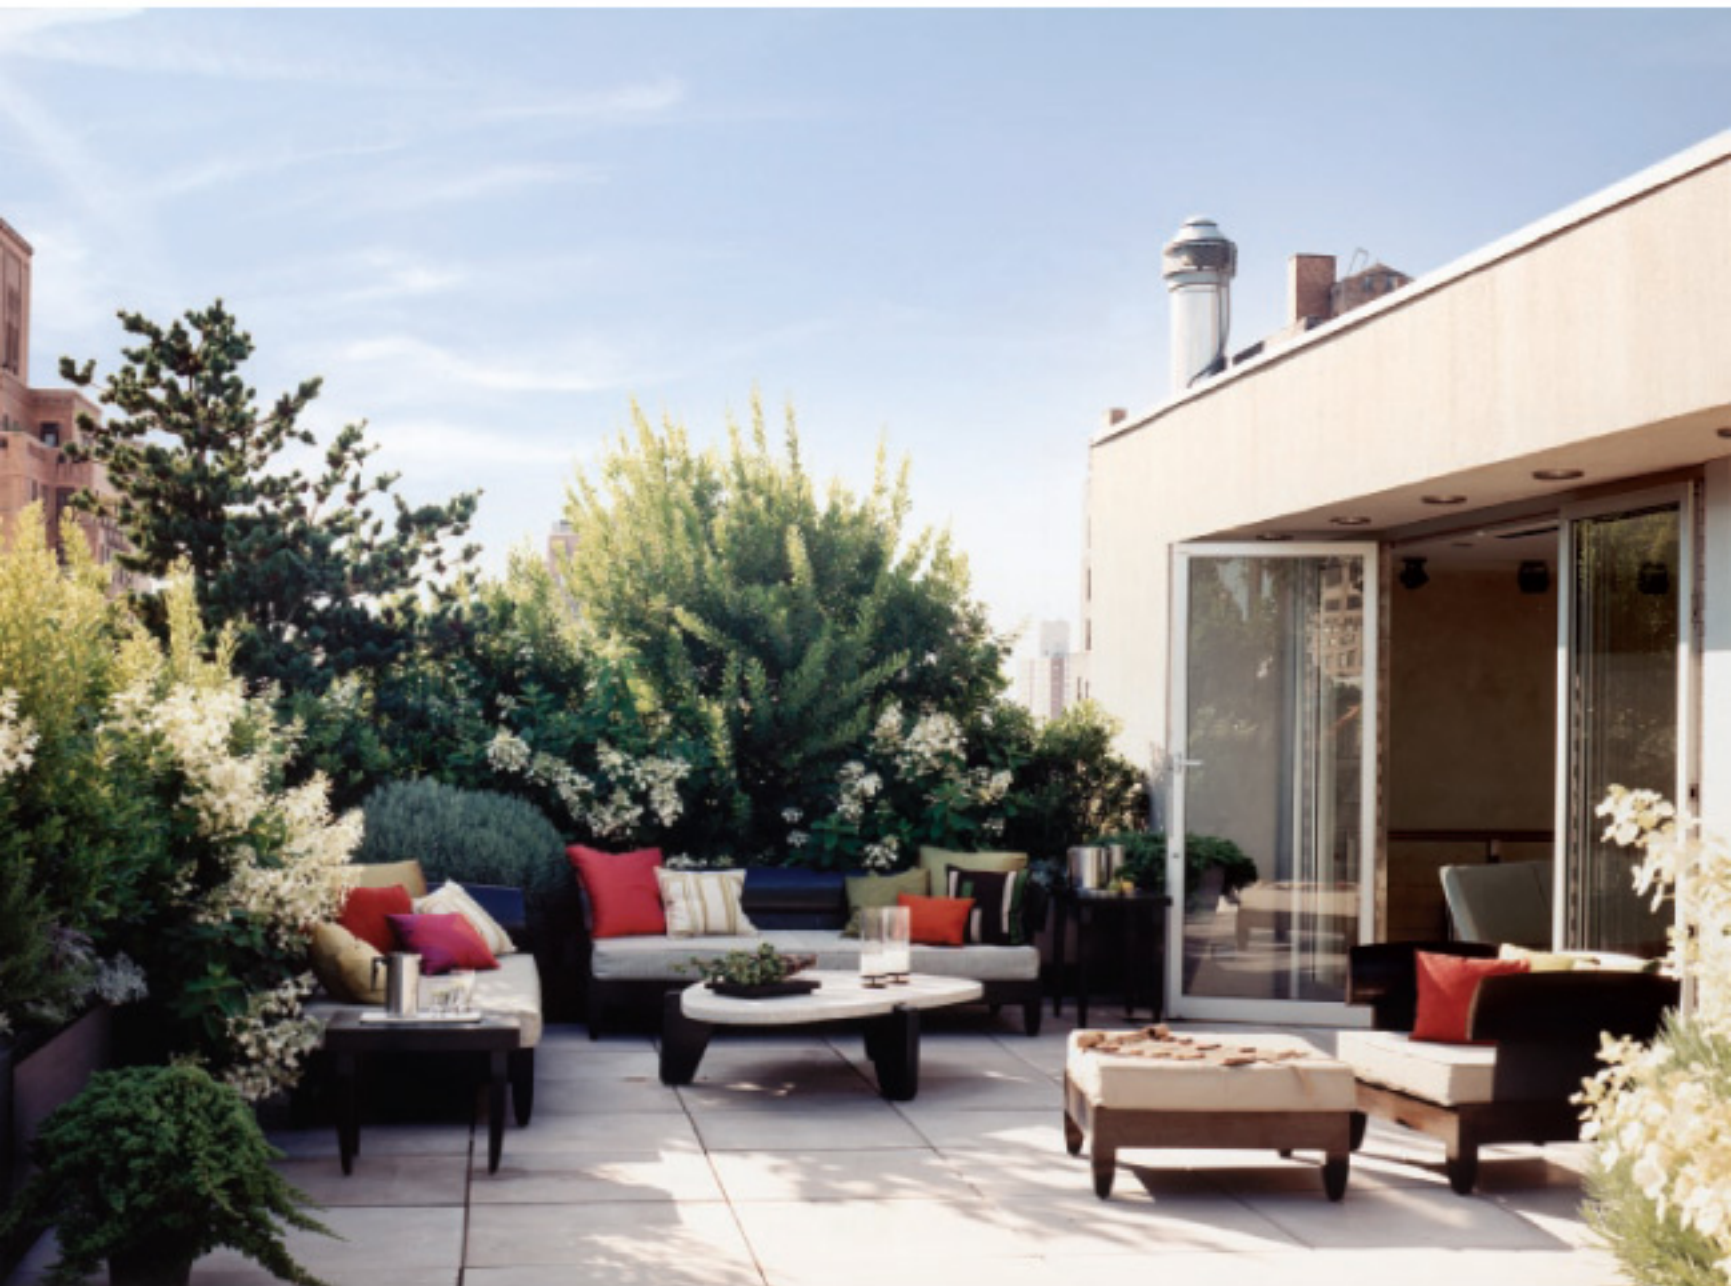
005

D5 Western view of the terrace lounge. (Photo: Dana Gallagher, ASLA Award Recipient)

图5 露台沙发休闲区的西边景色。(图片来源: 丹娜·伽拉格, ASLA获奖作品)

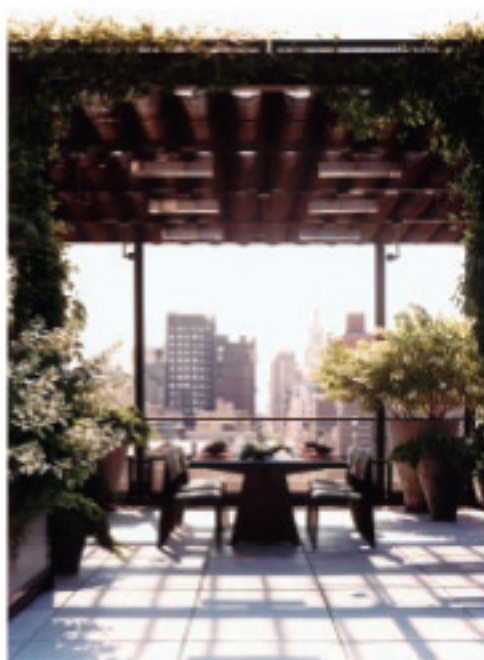
006

D6 View of the pergola and dining area with the eastern Manhattan skyline beyond. (Photo: Dana Gallagher, ASLA Award Recipient)

图6 藤架和餐厅, 以及东部曼哈顿矗立空中的建筑物外景。(图片来源: 丹娜·伽拉格, ASLA获奖作品)

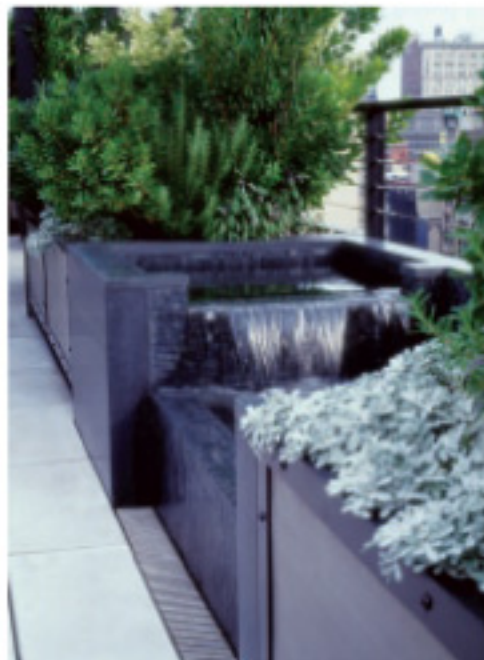
007

D7 Detail of the marble and glass mosaic fountain, and the railing to the top right. (Photo: Bill Cunningham, ASLA Award Recipient)

图7 用大理石和玻璃镶嵌成的喷泉池和右边的围栏 (图片来源: 比尔·坎宁安, ASLA 获奖作品)

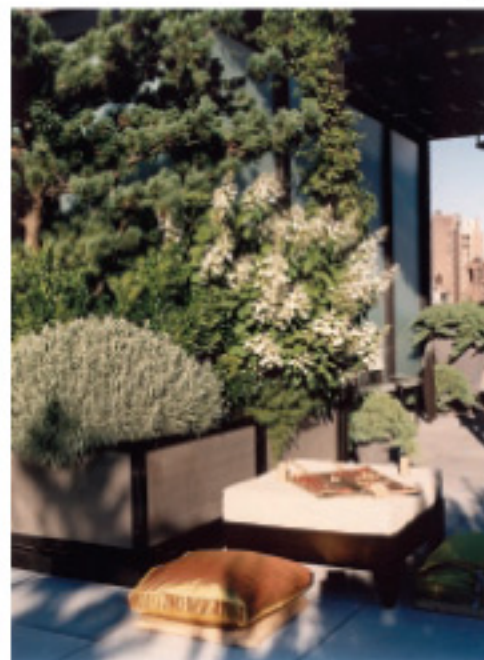
008

D8 Close-up view of the plantings and furnishings adjacent to the pergola and the enclosed shower. (Photo: Dana Gallagher, ASLA Award Recipient)

图8 藤架和浴室旁边的植物和家具近景 (图片来源: 丹娜·伽拉格, ASLA获奖作品)
